# Effects of Physical and Electrical Parameters on Damage Caused by Electrical Arcing

Aging Aircraft Electrical Systems

Federal Aviation Administration

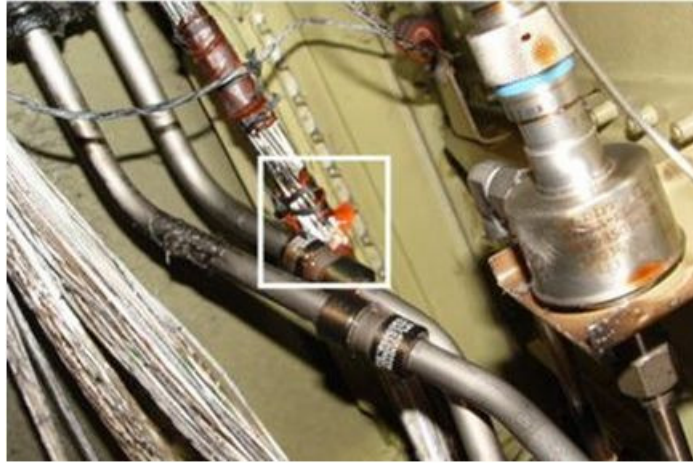
Figure 1. Failure initiation site is shown in the white box. Note that the wire bundle is lying on the hydraulic line. Red anti-chafe tape was used to protect the wiring.

A bundle containing 12 gauge 115 VAC power wires and protected with a three-phase 15 ampere thermal circuit breaker chafed to a high pressure titanium (typically alloy 3AI-2.5V) hydraulic line in a location rarely accessed by maintenance personnel (Figure 1).

The wire bundle was laying on the hydraulic line and vibration of the wire bundle on the hydraulic line couple chafed through the wire insulation. Exposed conductors arced to the titanium hydraulic line. Arcing was sufficient to breach the titanium tube, releasing 4,000 PSI hydraulic fluid that was subsequently ignited by continued arcing. Most damage to the remaining wiring, and loss of multiple systems, was due to external heating by a flame fueled by the spraying hydraulic fluid. Two 115 VAC three-phase 12 gauge wires arced to the hydraulic line. The 15 ampere thermal circuit breakers protecting the wires tripped at some point during the failure. A close-up of the wires that arced to the hydraulic line is shown in Figure 2.

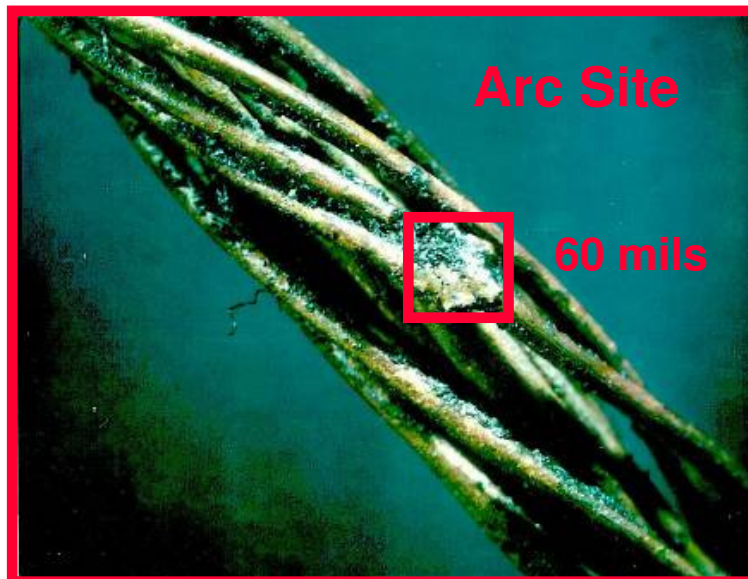
Figure 7. Close-up of copper wire found in electrical fire with arcing damage. Note small arc site compared to the aluminum hydraulic line in figure 17. SEM micrographs show the arcing was confined to several strands. EDS analysis found aluminum in the arc area.

Inspection of wiring located in the electrical fire identified a wire with arcing evidence. The 16 gauge wire was one phase of a 115 VAC three-phase circuit. A close-up the arc site is shown in Figure 7. Note the small size of the copper wire arc site, 0.060 inches (Figure 7) compared to the arc site of the aluminum line which was 0.25 inches (Figure 6). Arcing to the copper wire was confined to several strands and contained aluminum when examined with an SEM using EDS.

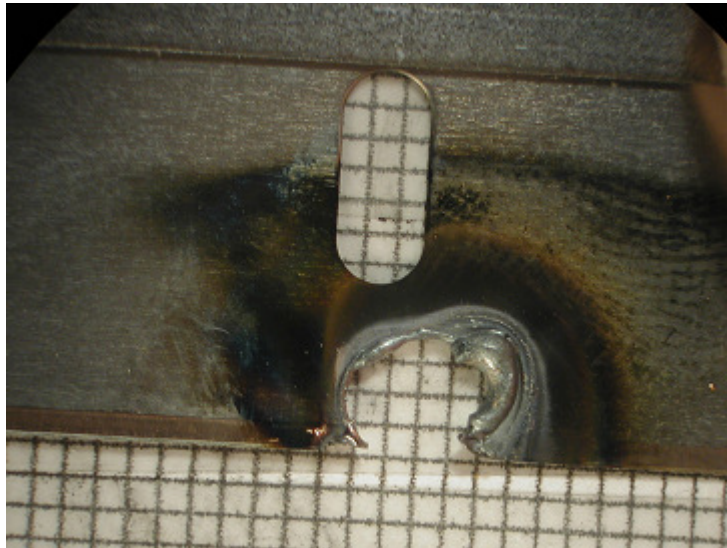
Figure 15. When razors were used as targets, the surface area damage was the nearly the same on both sides of the target (the razor blades were 10 mils thick). The figure above is representative of the damage from arcing to the razor blades. This photo is from TG-037-02. The scale in the photo is 1mm x 1mm.

Stainless steel razor blades were used in 7 test groups, all using the guillotine initiation method. In most of these tests, the damage to the razor blade was penetrating with very little variation between the front and rear side damage of the blade. For the razor blade, a simple surface area measurement was made and multiplied by the blade thickness to gather the material lost information. The small variation in blade thickness at the cutting edge was ignored.

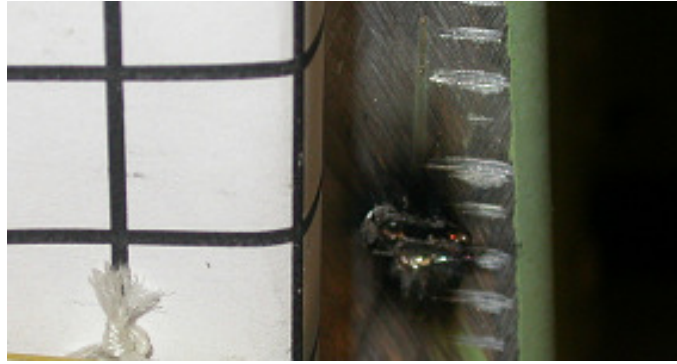
Figure 24. Damage to aircraft structure as the results of arcing. Some penetrating damage into the target, but there was no penetration of the structure. The above figure is from TG-018-01. The scale in the photo is 0.5 inch x 0.5 inch.

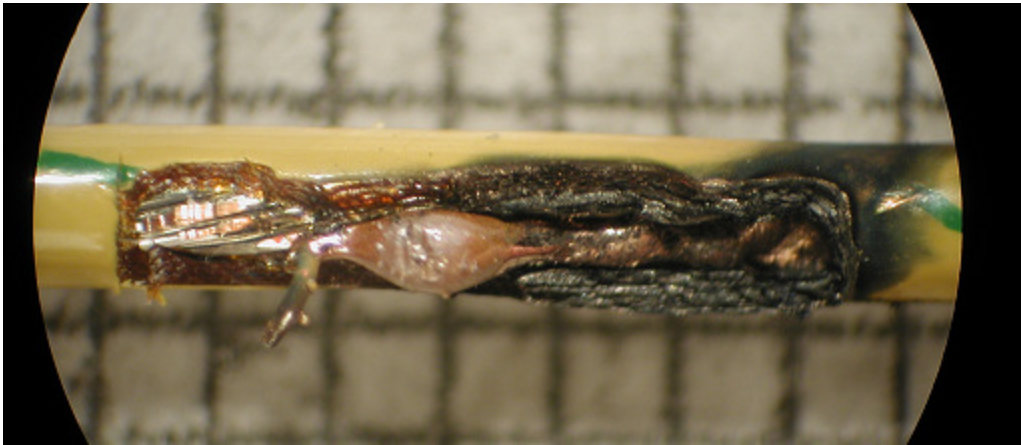
Figure 28. The damage to this wire is an example of the type of damage conductor damage seen. The above figure is from TG-141-02. The scale in the photo is 1mm x 1mm.
